Final report Tuhinga whakamutunga

Rail inquiry RO-2023-104 Passenger train (Te Huia) signal passed at danger and potential conflict Penrose, Auckland 17 June 2023

November 2024

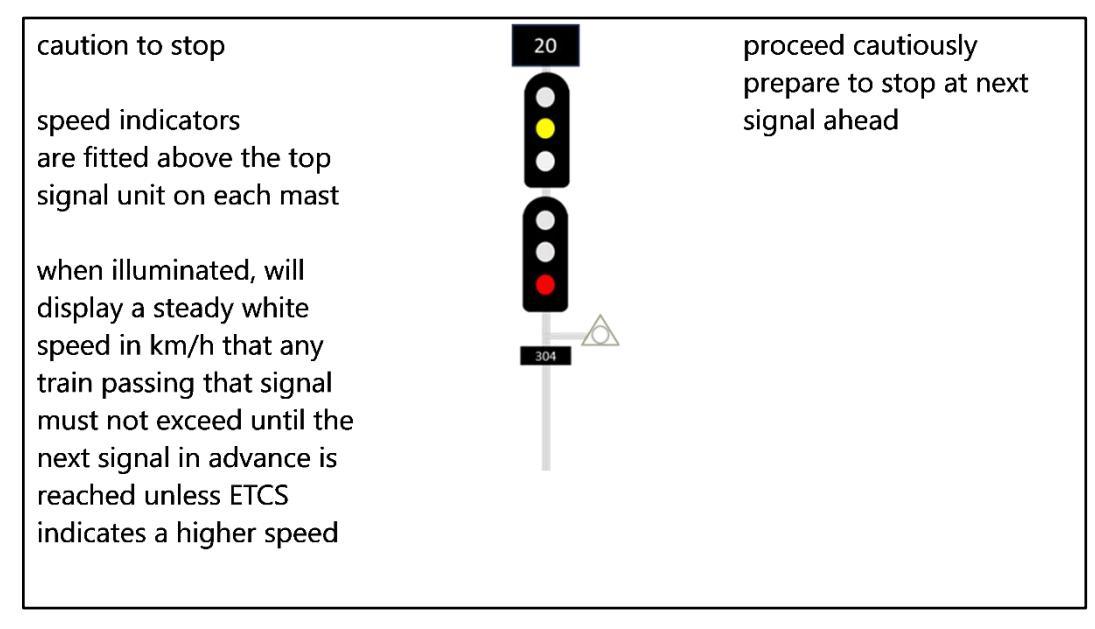
Figure 7: Signal aspect for 'caution to stop' and 'speed indicator¹¹'

2.10. Te Huia passed this signal at about 0951 and was then approaching signal 304, the home¹⁰ signal to Penrose Station. The signal was displaying a steady yellow aspect in the top unit with a red aspect in the bottom unit. The signal was supplemented with a steady white numeral '20', which indicated a caution and that the next signal could be

at stop. The maximum permitted speed for Te Huia was 20 kilometres per hour after passing that signal (*see* Figure 7).

- 2.11. Te Huia passed signal 304 at a speed of about 36 kilometres per hour. The LE was still applying power, with the train's speed decreasing to about 32 kilometres per hour. The track on approach to Penrose was on an ascending grade of about 1:50, with the track curving to the right on approach to the station.
- 2.12. At about 0952, with the speed still at about 32 kilometres per hour, the LE sighted signal 312 at Penrose Station. The signal was displaying a Normal clear with a green aspect in the top unit and a red aspect in the bottom unit (*see* Figure 8). This signal was located to the left of the track.

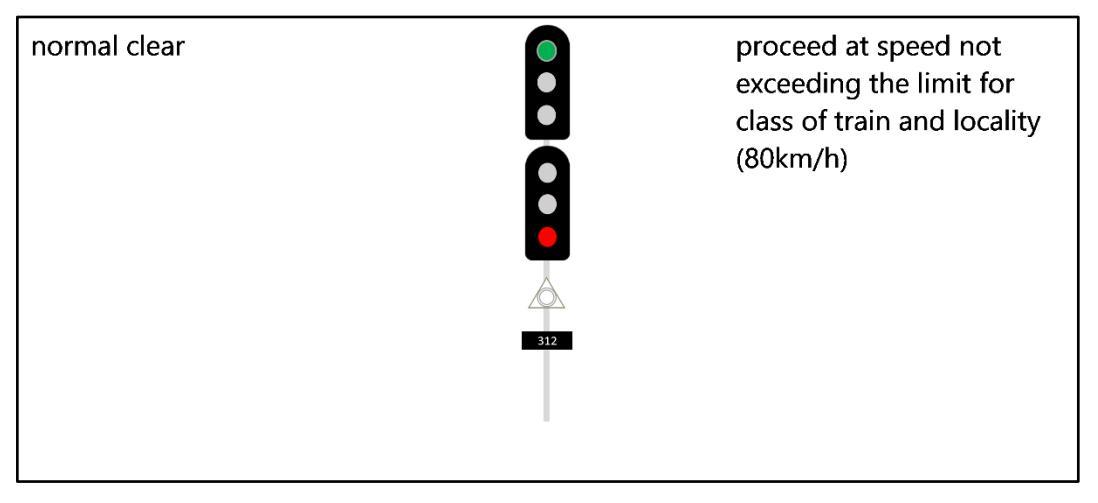
2.13. The LE responded by increasing power and taking the train's speed up to 50 kilometres per hour as it continued towards Penrose Station. The signal the LE had observed,

signal 312, was the signal for the Onehunga branch line (OBL), and not a signal for the NAL on which Te Huia was operating.

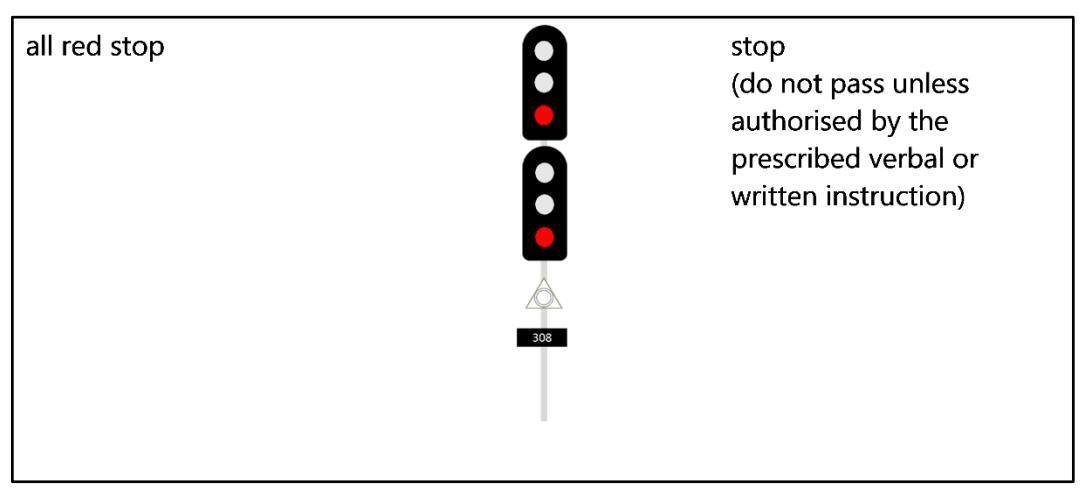
Figure 9: Signal aspect for 'all red stop' signal

2.14. The signal applicable to the NAL was signal 308, which was located to the right of the track beyond the station platform and not in the LE's view. This signal was displaying a red aspect in the top and bottom units, meaning trains had to stop and proceed only when authorised (*see* Figure 9). The signal was set to stop to allow for the passage of a commuter train onto the NAL through the 373A points¹² at the OBL junction.

- 2.15. As Te Huia continued past the station, the LE saw the red aspect of signal 308 in their peripheral vision. They realised that they had identified the incorrect signal for the route, and responded by applying the train's brake handle into a 'handle off' position¹³. The LE thought they had applied the train brake handle to the emergency position¹⁴.
- 2.16. Te Huia continued past signal 308 and travelled a further 195.2 metres before coming to a stop. The train could not be stopped and ran through¹⁵ and damaged the 373A points at the OBL junction (*see* Figure 10).
