Transport Accident
Investigation
Commission

Final report

Rail inquiry RO-2023-106
Passenger train 804 TranzAlpine
Train parting
Arthur's Pass
17 December 2023

May 2025

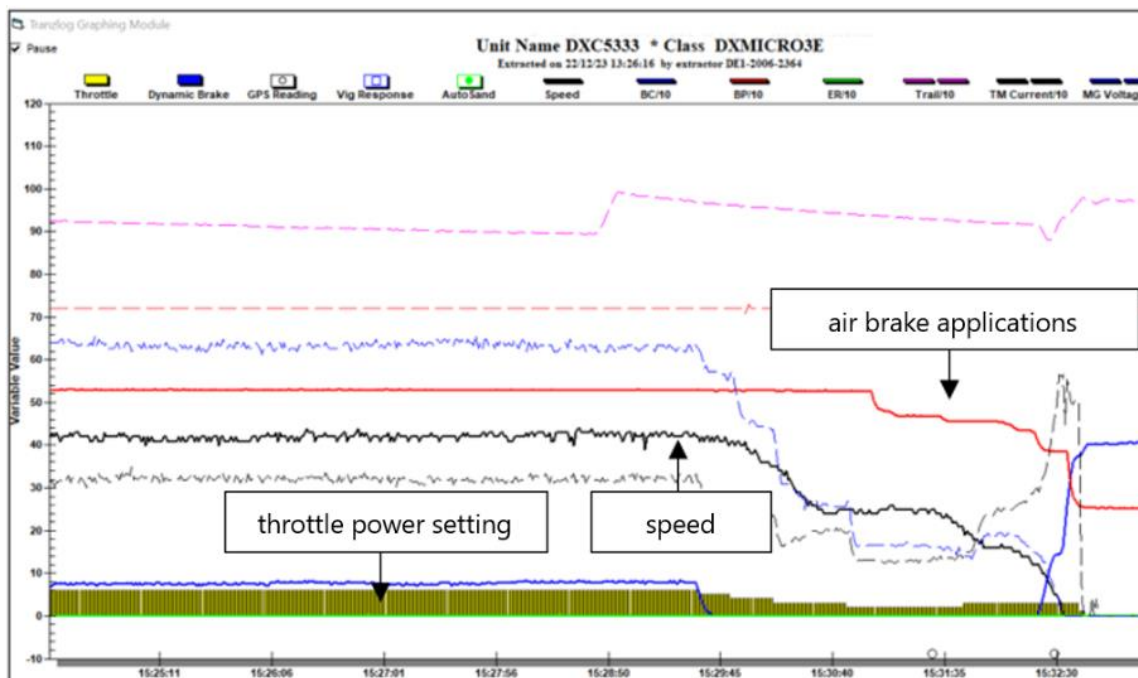
Figure 13: Tranzlog data from locomotive

- 2.40. The front locomotive was fitted with a Tranzlog data recording system.³⁰ The Transport Accident Investigation Commission (the Commission) obtained and analysed the Tranzlog data (see Figure 13). See Section three for discussion of the Tranzlog data.

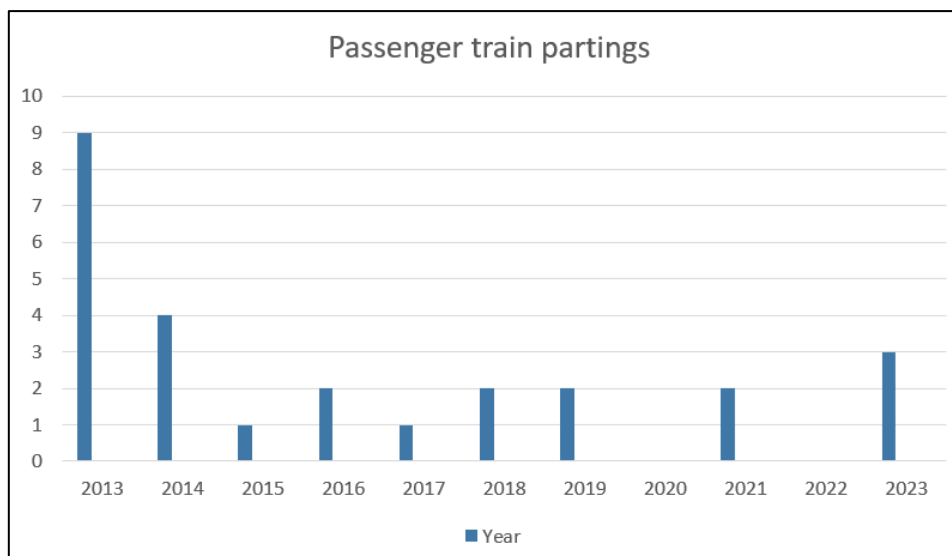
Figure 14: Passenger train parting between 2013 and 2023

- 2.44. The Commission obtained data from 2013 to 2023 on New Zealand passenger train partings (see Figure 14). This data showed that partings predominantly involved automatic type couplers with a manual release handle and locking pin³² (the coupler

type in carriage one). Fewer partings involved semi-permanent couplers³³ with pneumatic and electrical interlocking connections used on commuter services.

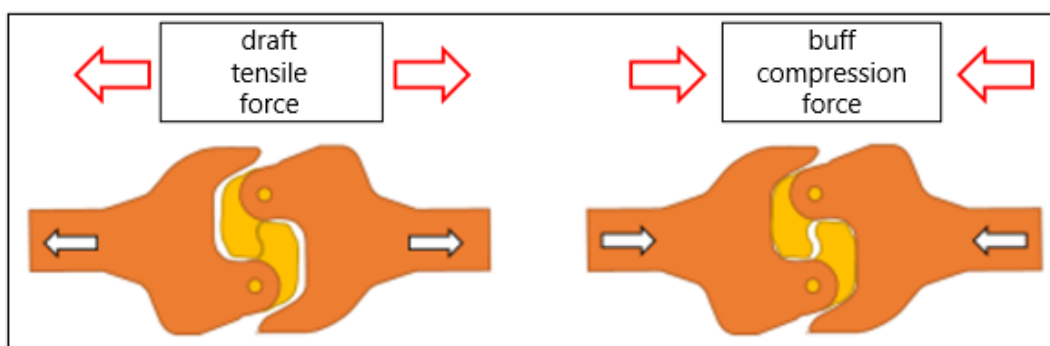
Figure 15: Longitudinal couple movement forces

- 3.7. In-train forces can be exacerbated when bringing the train to a complete stop. Careful consideration is required when using the train's brake and the locomotive's throttle power setting to minimise the forces applied to carriage couplers.

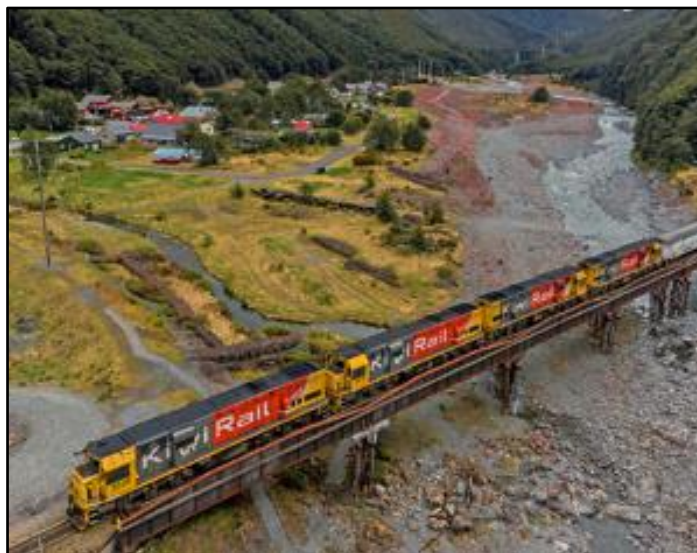
Figure 16: Four locomotives attached to the TranzAlpine

- 3.11. On the day of the incident, the train's normal locomotive configuration was increased from two to four locomotives (see Figure 16). While not common practice for the passenger service, this configuration was within KiwiRail's Operating Rules. If being operated in this configuration, the rules at the time required the third locomotive's power supply to be isolated, which did not occur on the day of the incident.

- 3.12. The train then had two locomotives attached to the rear carriage, as required to travel through Otira tunnel. The train's total weight was then 999 t, with 591 t located behind carriage one's coupler at the front of the train.
- 3.13. The slight downward gradient towards Arthur's Pass station combined with the application of the train brakes, and having power applied to all four locomotives, stretched the train and applied draft tensile force to the carriages. This method of slowing the train is commonly used with limited or no throttle power, when the front

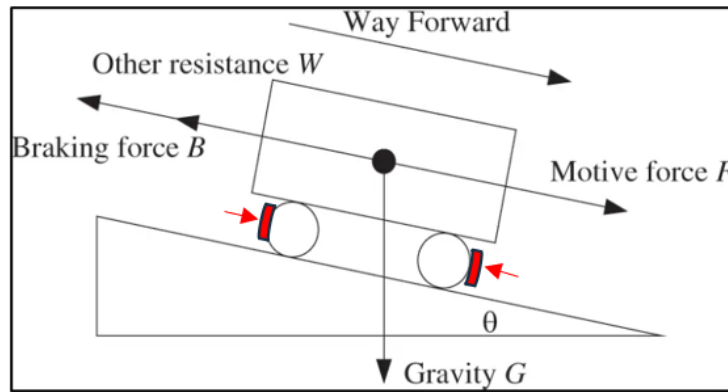
Figure 17: In-train force and braking resistance

- 3.14. As further brake applications were made, the braking force increased (see Figure 17). The front four locomotives remained in throttle power three, generating a motive force in the opposing direction.

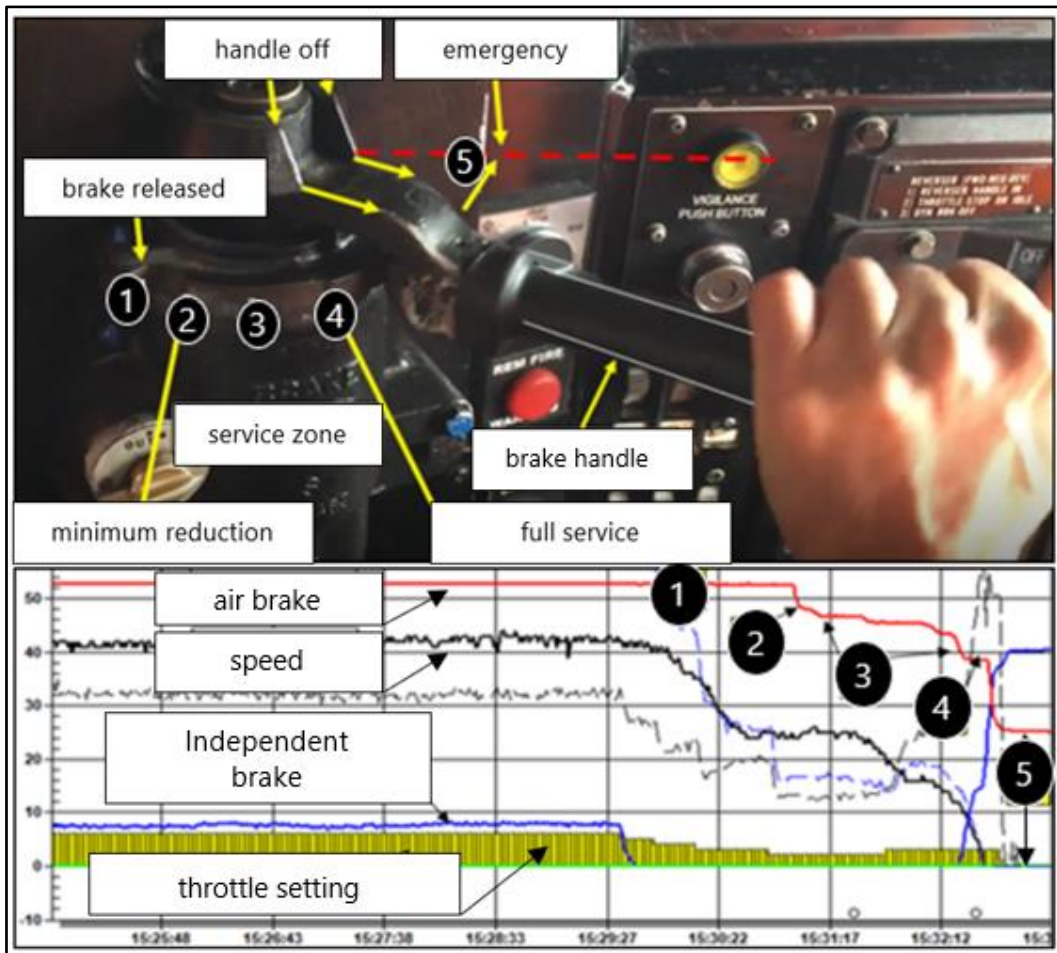
Figure 18: Train air brake application positions overlaid onto Tranzlog data

- 3.16. Analysis of the Tranzlog data showed that the LE's use of the graduated train brake and throttle power when approaching Arthur's Pass station did not follow the guidelines and increased the force applied to the carriage couplers (see Appendix 3 for the train's air brake response functions) (see Figure 18).

- 3.18. Simulator testing conducted by KiwiRail indicated that approximately 99 kN of draft tensile force was put on the coupler connection between carriage one and carriage two when operating the graduated braking system in accordance with the guidelines.

- 3.19. In response to the incident, KiwiRail produced a Job Aid instruction for LEs to reinforce the approved procedures for stopping passenger trains at Arthur's Pass station (see Appendix 4).

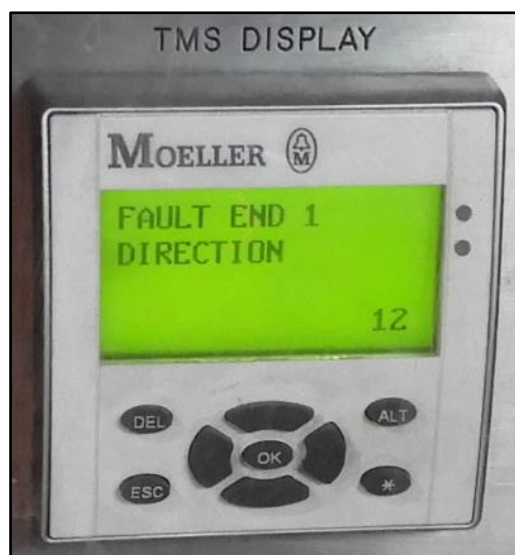
Figure 30: TMS display panel during simulation

- 3.52. When Commission investigators simulated the parting, with the brake pipe and power lead disconnecting, they recorded the TMS sounding for approximately four seconds and the TMS display panel indicated "FAULT END 1 DIRECTION" (see Figure 30).

- 3.53. On the day of the incident, it is **very likely** the alarm activated as required. However the TM did not recall the TMS display activating or the TMS alarm sounding when the train parted.
- 3.54. The alarm activation period of four seconds was short, during which the crew continued with their duties. Research shows that different alarm types and durations should be considered when they are associated with a safety risk (see citations).
