**Report 06-005, Gippsland Aeronautics GA8 Airvan, ZK-KLC, partial engine failure,
Cook Strait, 27 November 2006**

Report 06-005

Gippsland Aeronautics GA8 Airvan

partial engine failure

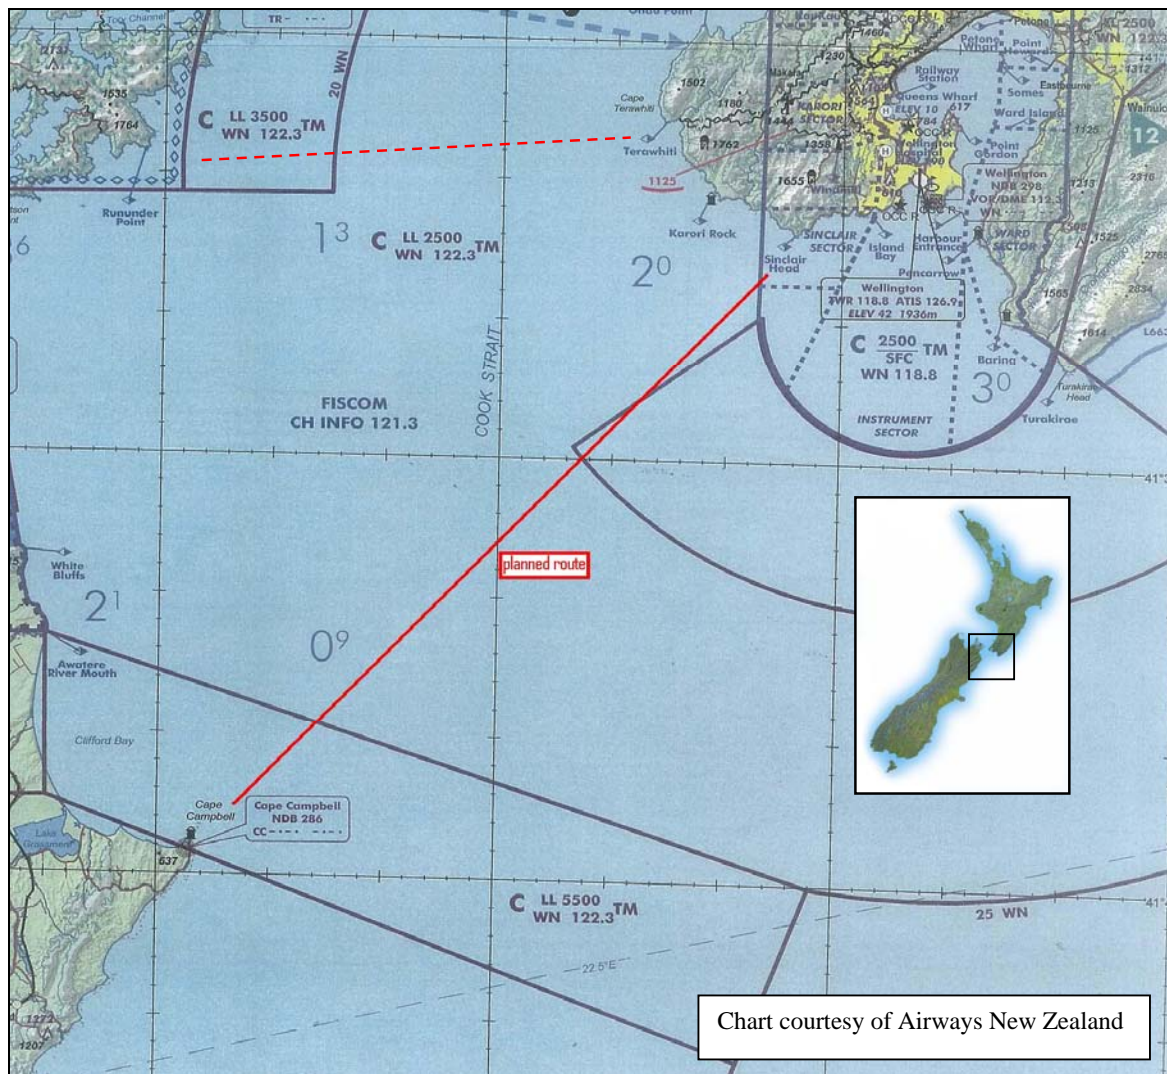
Figure 1
Planned route, Sinclair Head to Cape Campbell

- 1.1.3 The pilot had intended to cross Cook Strait from Sinclair Head directly to Cape Campbell at 3000 feet (see Figure 1) because the weather was fine. The intended route was popular for visual flights between the North and South Islands, even though it was over water for 56 km, because it was about 38 km shorter than crossing between Cape Terawhiti and Rununder Point and then following the coast to Cape Campbell. The pilot's company (the operator) had not stipulated a minimum cruise altitude for the direct route.

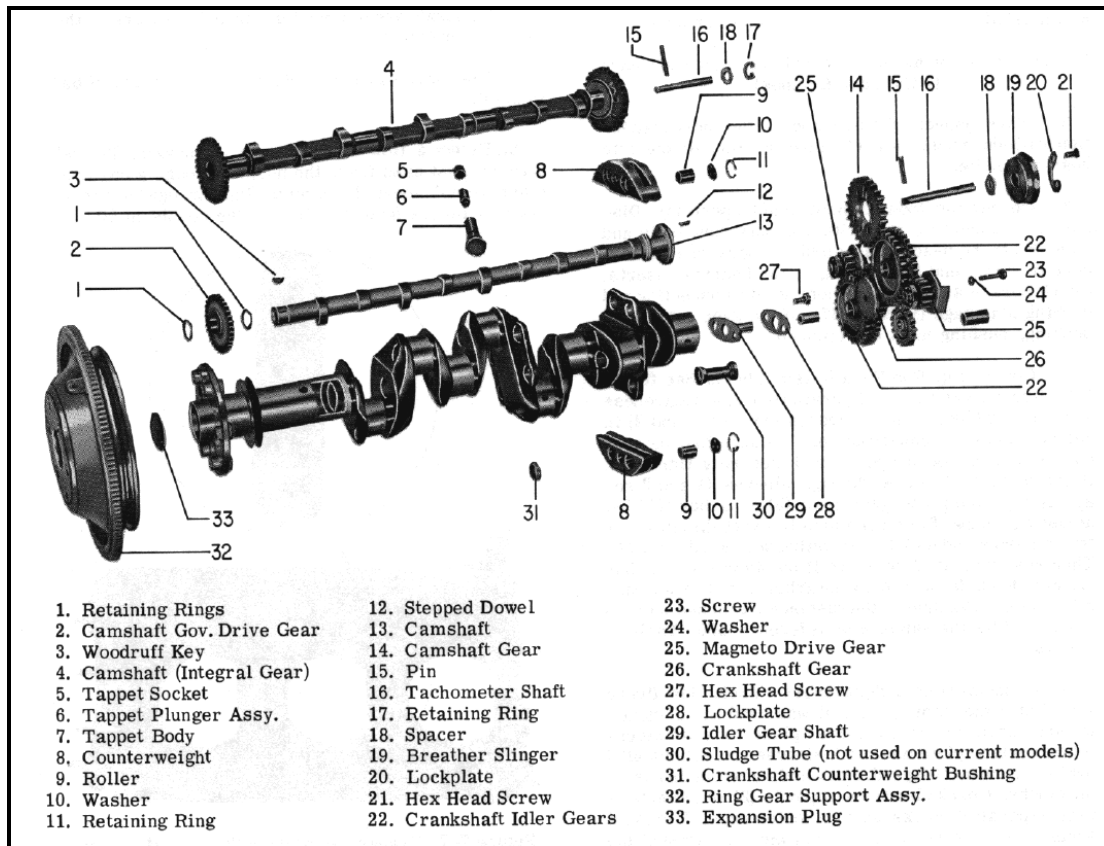
Figure 4
Diagram of a typical crankshaft and related parts
 (Source: Lycoming overhaul manual)

- 1.3.15 Figure 4 shows the crankshaft and other rotating parts of an engine of similar configuration to the Lycoming IO-540-K1A5. The crankshaft is not numbered in the figure, but items 4-7 are parts often referred to in this report.

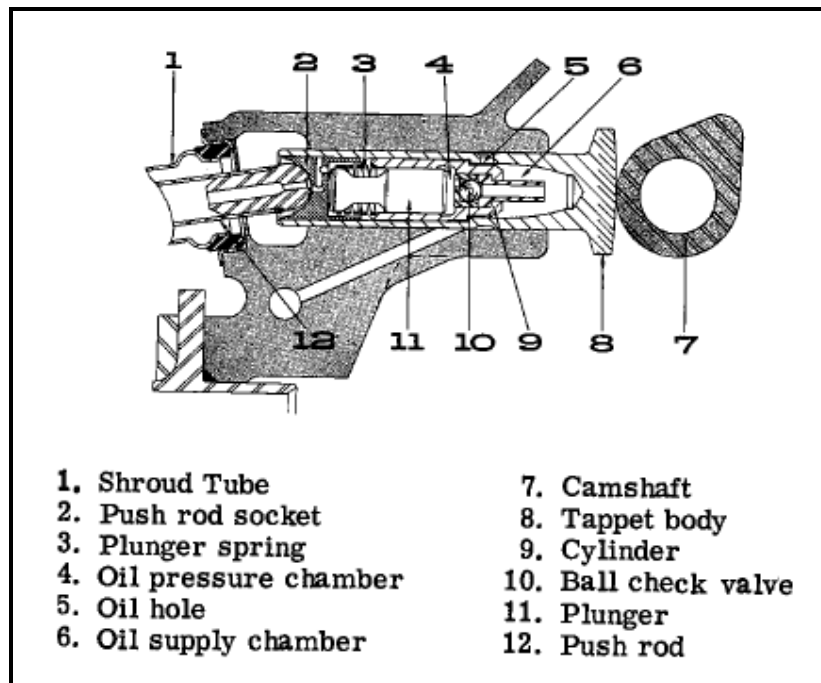
Figure 5
Diagram of a typical hydraulic tappet
(Source: Lycoming overhaul manual)

- 1.3.16 A conventional camshaft was located above and parallel to the crankshaft. The camshaft lobes acted on self-adjusting tappets, also called hydraulic tappets (see Figure 5). These moved the push rods that operated the valve assemblies in each cylinder. The self-adjustment feature used engine oil pressure to keep the tappets in light contact with both the camshaft and push rods at all times in order to prevent impact loading and smooth the engine operation.

- 2.13 In order for the #4 exhaust valve push rod socket to have displaced from the tappet body enough for it to strike the shroud tube, a gap had to have opened between the push rod and the hydraulic tappet (see Figure 5). The single witness mark on the shroud tube showed that the socket had been displaced or misaligned only once.
