**Report 06-007, Kawasaki-Hughes 369HS, ZK-HDJ, collision with terrain,
Mount Ruapehu, 11 December 2006**

Report 06-007

**Kawasaki-Hughes 369HS
ZK-HDJ**

collision with terrain

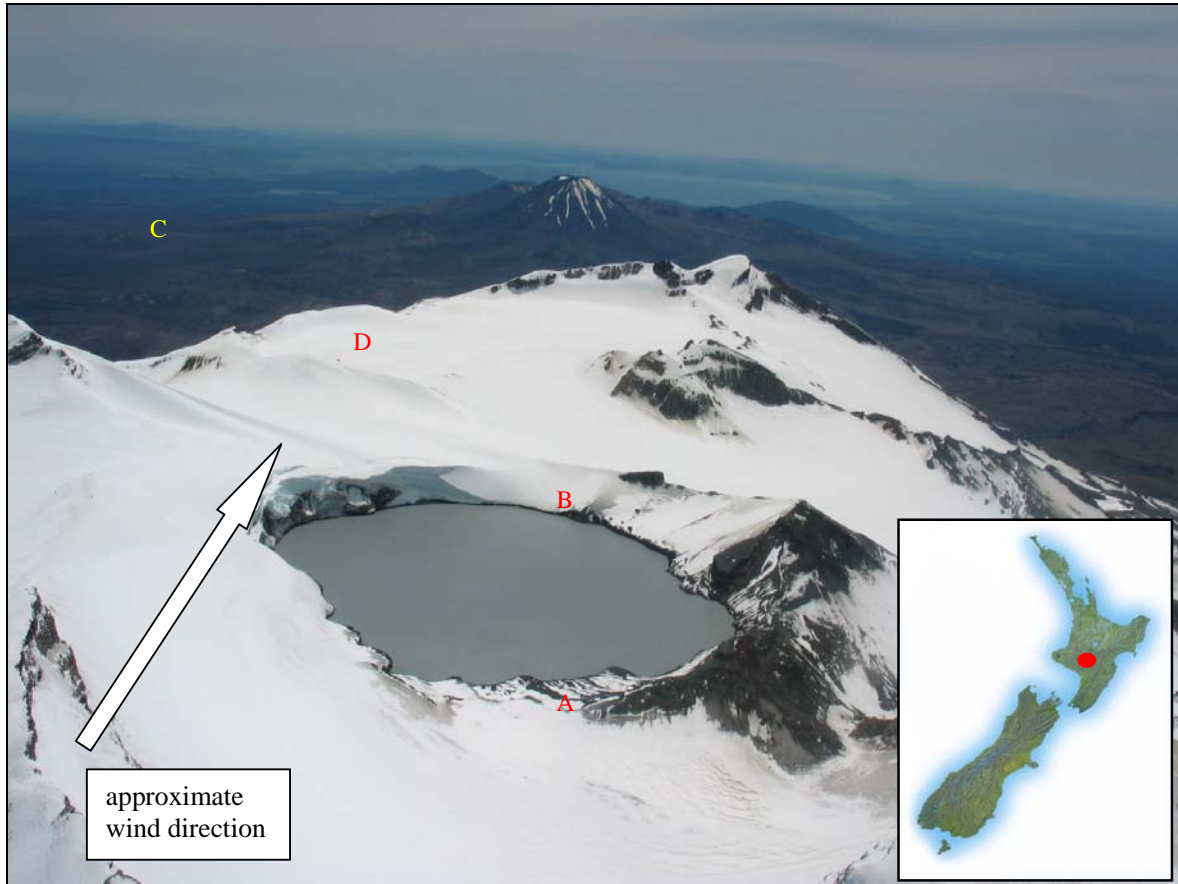
Figure 1

Mount Ruapehu Crater Lake, looking north

- 1.1.4 Late in the afternoon, the pilot agreed to a request, advised by the supervisor of the weed task, to uplift a park ranger (ranger A) from a point high on Mount Ruapehu and return him to the park headquarters. The pilot understood that the pick-up was to be from near Dome Shelter (see Figure 1), where he had flown a DOC task previously. He also agreed to the supervisor’s request that a ranger from the weed team (ranger B) go on the flight because ranger B was understudying ranger A’s work.
