**Report 07-011, Cessna A152 Aerobat, ZK-KID, impact with terrain,
Te Urewera National Park, 23 kilometres south-east of Murupara, 26 October 2007**

Report 07-011

**Cessna A152 Aerobat
ZK-KID**

impact with terrain

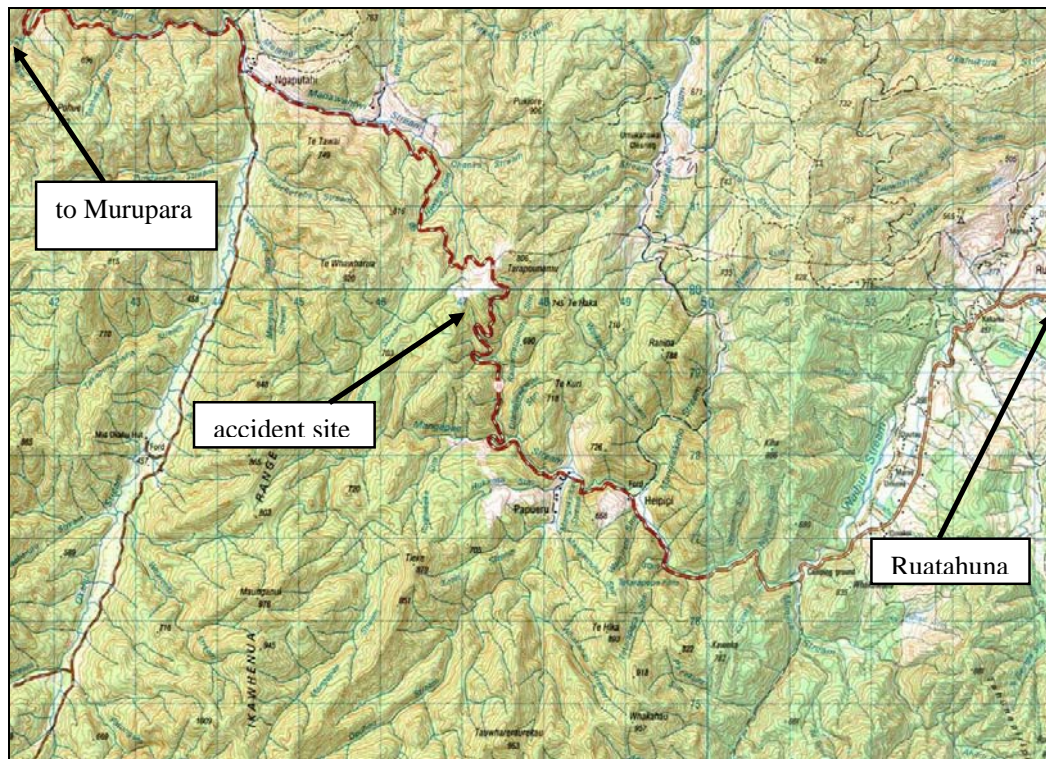
Figure 2
Location map 2

- 1.1.10 The student reported that after leaving Ruatahuna the terrain rose steadily, so the aircraft was slowly climbed to maintain the same height above the road (see Figure 2). It also became increasingly windy and turbulent, and after several minutes the instructor took control of the aircraft, estimated by the student to be about 2 or 3 minutes before the accident. No explanation was given for taking control, but the student thought it was because of the turbulence, including localised downdraughts, and to give him a break from flying.

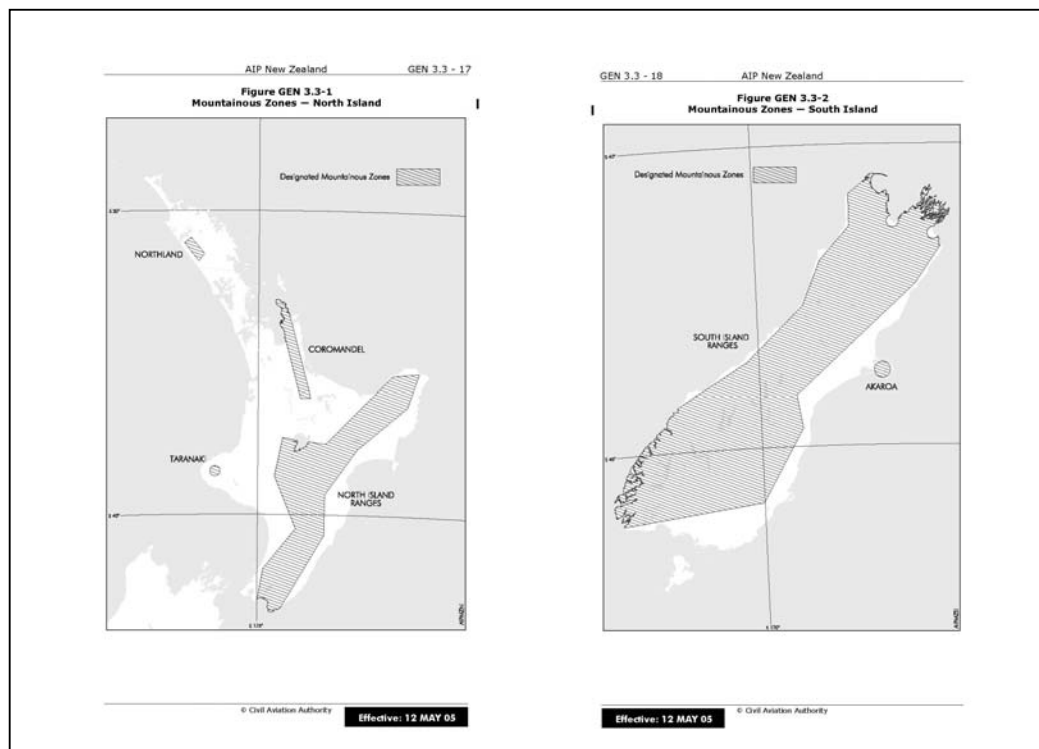
Figure 5
Designated mountainous terrain in New Zealand
(courtesy of Airways New Zealand)

- 1.5.1 About 60% of New Zealand terrain is classified as mountainous (see Figure 5). The rest, with some exceptions, is typically undulating. Pilots generally could spend a majority of their time flying over or at times through topography that was varied, demanding and unforgiving. For those electing to fly through mountainous terrain, such flying in particular placed unique demands on pilots' skills.
- 1.5.2 On 25 October 1993, ZK-NOM, a GAF N22 Nomad (Transport Accident Investigation Commission (TAIC) Report 93-014), impacted on the Franz Josef Glacier while on a scenic flight from Glentanner to Queenstown. Two pilots and 7 passengers were killed in the accident. The investigation found that neither pilot had received any mountain-flying training and that they had little experience flying in the area.
