**Report 09-005: Cessna 182N ZK-FGZ and Bombardier DHC-8 Q311 ZK-NEF,
loss of separation and near collision, Mercer, 40 km south of Auckland, 9 August 2009**

Report 09-005

**Cessna 182N ZK-FGZ
and
Bombardier DHC-8 Q311 ZK-NEF**

loss of separation and near collision

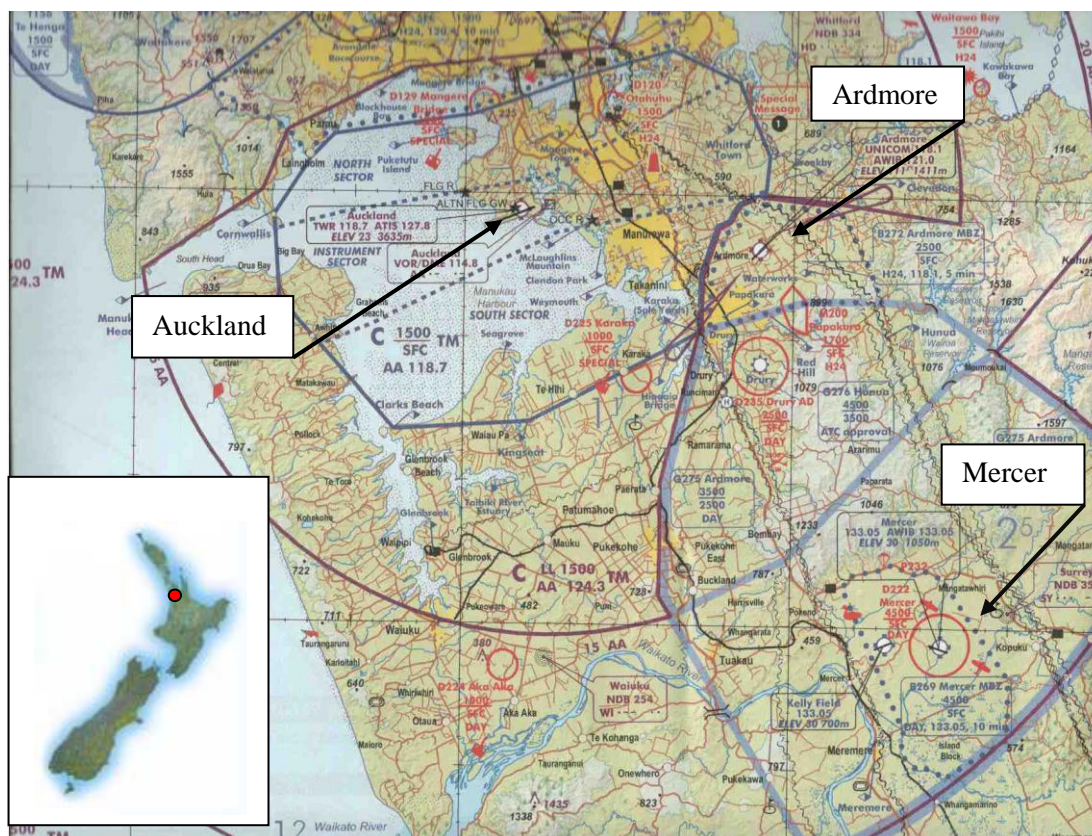
Figure 1
Visual navigation chart
(Courtesy of Airways)

- 1.1.1 On Sunday 9 August 2009, ZK-FGZ, a Cessna 182N aeroplane, was being used to conduct parachuting operations from Mercer Aerodrome, about 40 km south of Auckland International Airport (see Figure 1). At about 1150, following an uneventful first drop of parachutists, the pilot started loading a second group of parachutists on-board the aircraft. The group consisted of 4 jumpers and the pilot, making 5 persons on board.

- 1.1.6 At 1216:12 the pilot of ZK-FGZ reported “4 minutes to drop”.⁹ ZK-FGZ was climbing through about 10 000 feet at the time. The controller responded with “Foxtrot Golf Zulu is now cleared Mercer PDA”. The pilot acknowledged the clearance, which, in accordance with an agreement between the operator and Airways Corporation of New Zealand (Airways), permitted the pilot to operate unrestricted within the Mercer PDA and release the parachutists (Mercer Skydiving Centre and Airways, 2007).

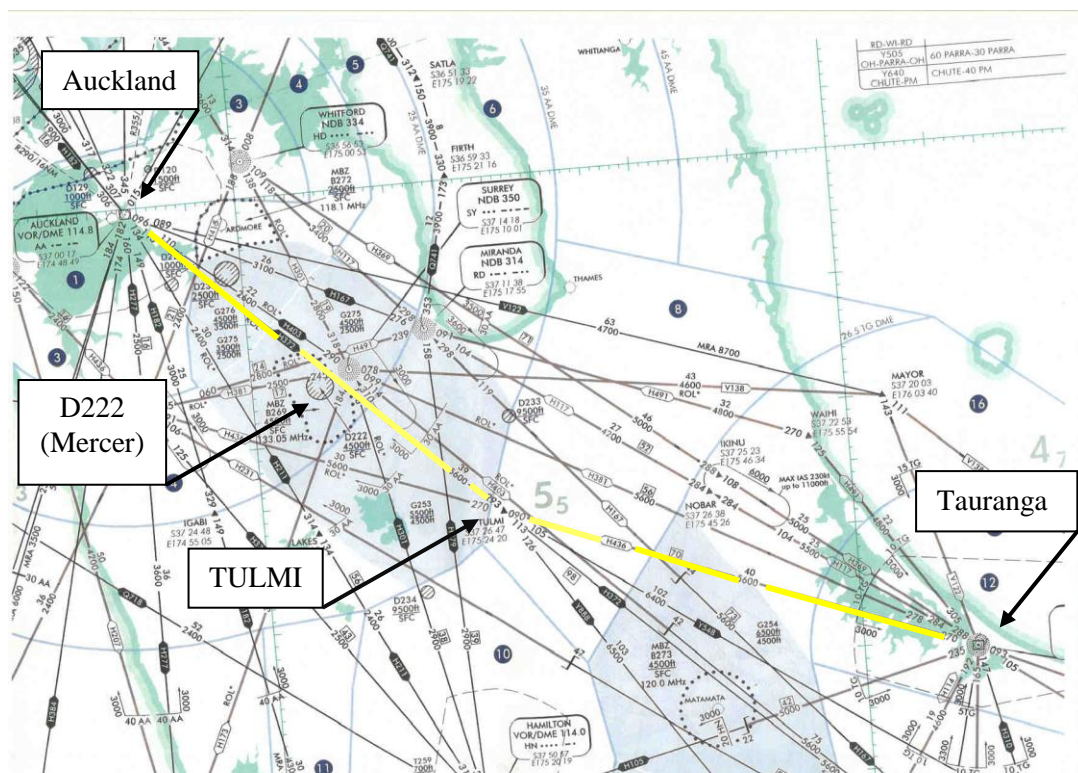
Figure 2
En-route chart
(Courtesy of Airways)

- 1.1.7 Nearly 2 minutes later at 1218:03, after communicating with 2 other aeroplanes, the controller cleared Airlink 223 “direct TULMI”. TULMI was a reporting point about midway between Auckland and Tauranga (see Figure 2; AIP, 2009a). The captain acknowledged the new clearance and the aircraft was turned right towards TULMI. At this time Airlink 223 was climbing through about 4500 feet and ZK-FGZ was to the west of Mercer Aerodrome, heading south and approaching 11 000 feet.

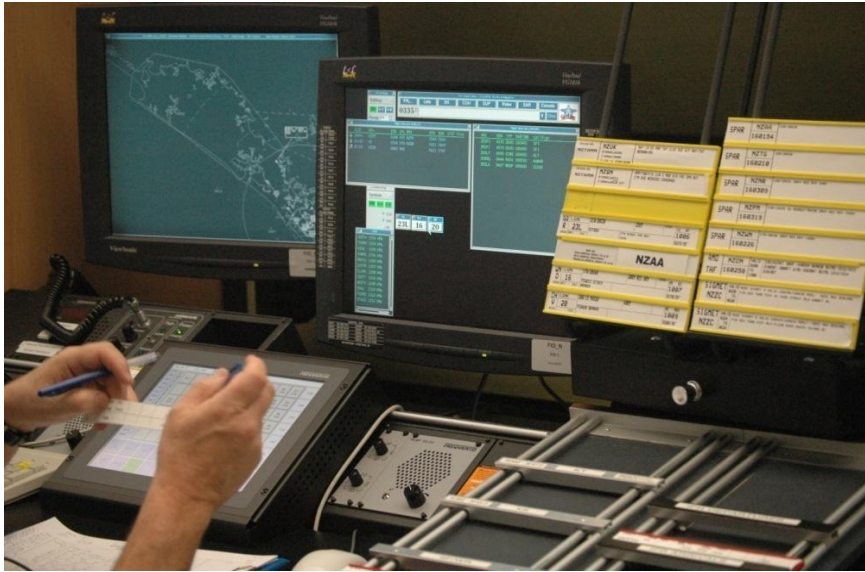
Figure 5
A radar planner's position
(Courtesy of Airways)

- 1.2.6 The controlling of aircraft in the Auckland terminal sector was performed by the AATMR controller. A planner would sit alongside the controller and assist as directed (see Figure 5). The duties of the planner included, among other things, issuing route clearances, creating flight plans, briefing the controller on updated weather reports and alerting the controller "to potential opposite direction traffic conflicts" (Airways, 2008b).¹⁴
