Transport Accident
Investigation
Commission

Final report

Marine inquiry MO-2021-205
Container vessel Moana Chief
Serious injury to crew member
Port of Auckland, New Zealand
10 December 2021

April 2023

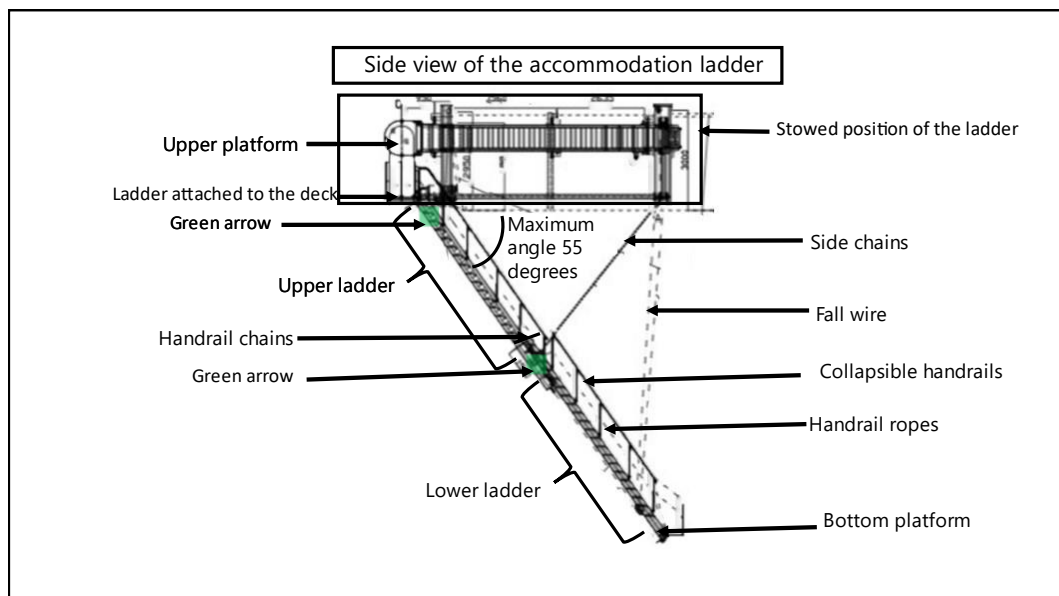
Figure 3: Side view of the telescopic accommodation ladder

- 2.1 Typically, a telescopic¹ accommodation ladder² (the ladder) is made up of two parts: a fixed upper ladder and a moving lower ladder.
- 2.2 Onboard *Moana Chief* (the vessel) the top of the upper ladder was hinged on a turntable mounted onto a platform attached to the ship's deck. The bottom of the upper ladder was supported by two side chains (see Figure 3).
- 2.3 The lower ladder was telescopic and could be extended or retracted. It was secured to the upper ladder by an interlocking guide and rollers. There was an overlap between the two ladders of about 1.5 metres, which provided support and helped maintain rigidity and strength.

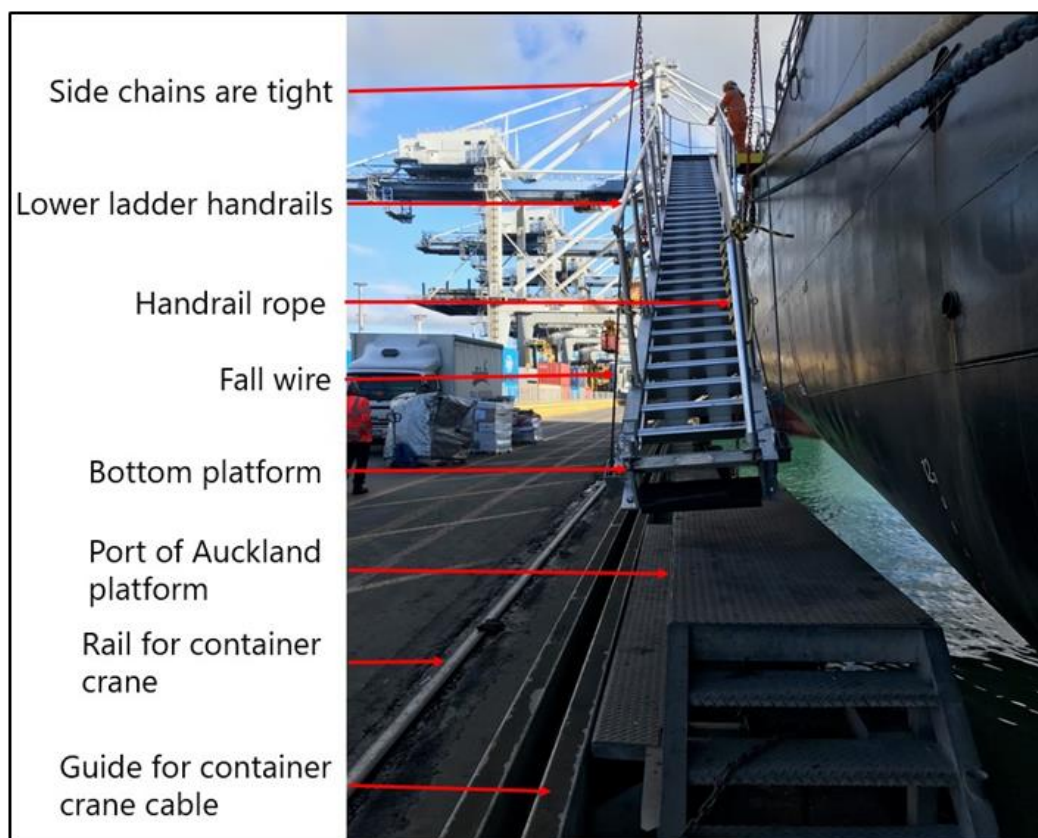
Figure 5: Ports of Auckland Limited platform and accommodation ladder

- 2.8 Two additional IRs helped to remove and stow the accommodation ladder safety net.
- 2.9 The ladder was resting on top of a steel platform known as the Ports of Auckland Limited platform (the Port platform) (see Figure 5). The Port platform was designed to keep the ladder clear from obstructions on the wharf and prevent it from impeding the safe operation of the container cranes, which ran on dedicated rails close to the side of the vessel.

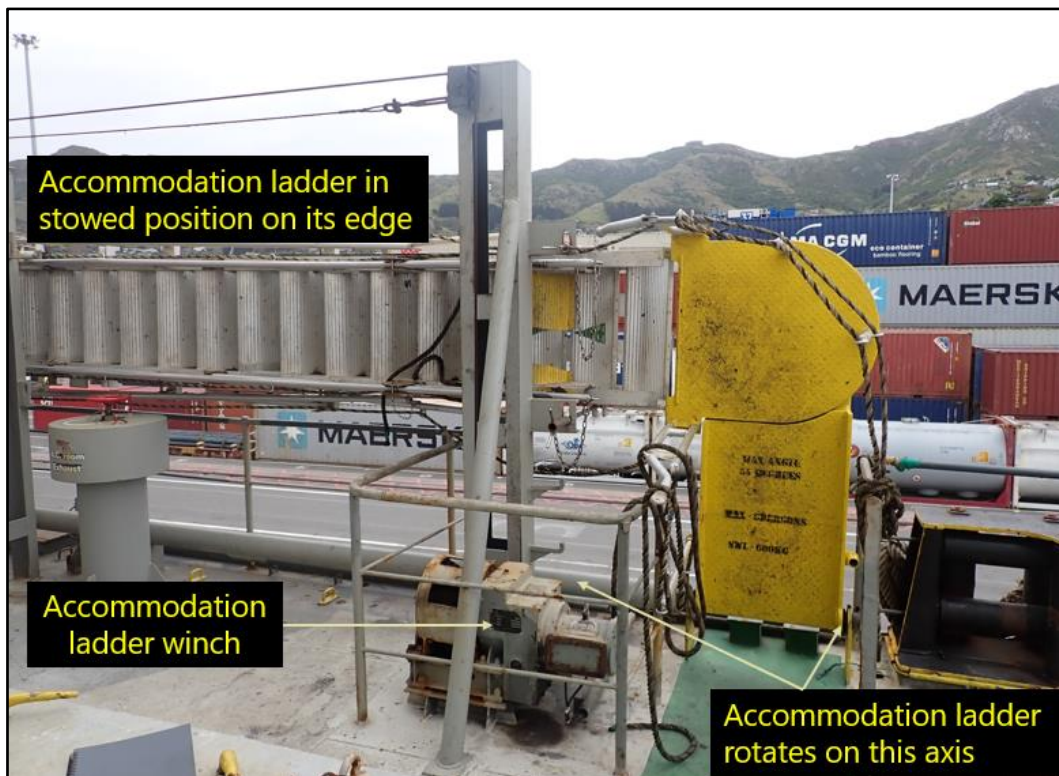
Figure 9: Accommodation ladder in stowed position and winch

2.47 In the stowed position the ladder rested on its edge along the ship's side (see Figure 9). The ladder was designed to deploy using gravity. By slackening the fall wire the ladder rotated from its stowed position to a horizontal position outboard of the ship's siderail.

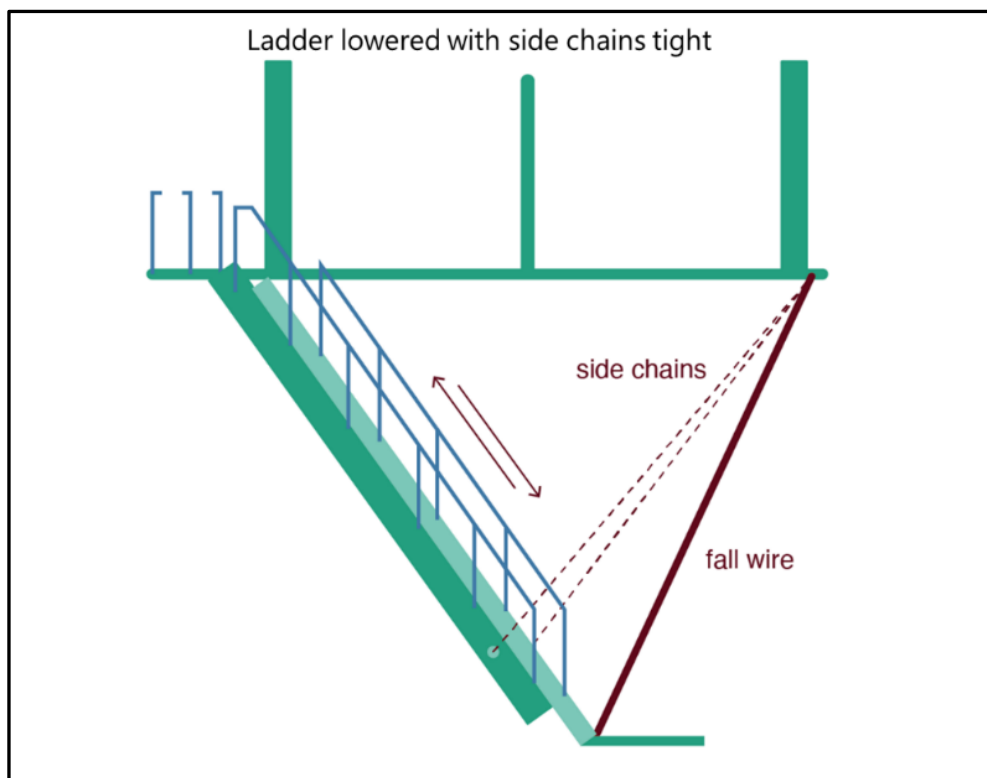
Figure 10: Ladder lowered with side chains tight

2.49 Further slackening of the fall wires lowered the upper ladder until the side chains were tight and were supporting the weight of the upper ladder (see Figure 10).

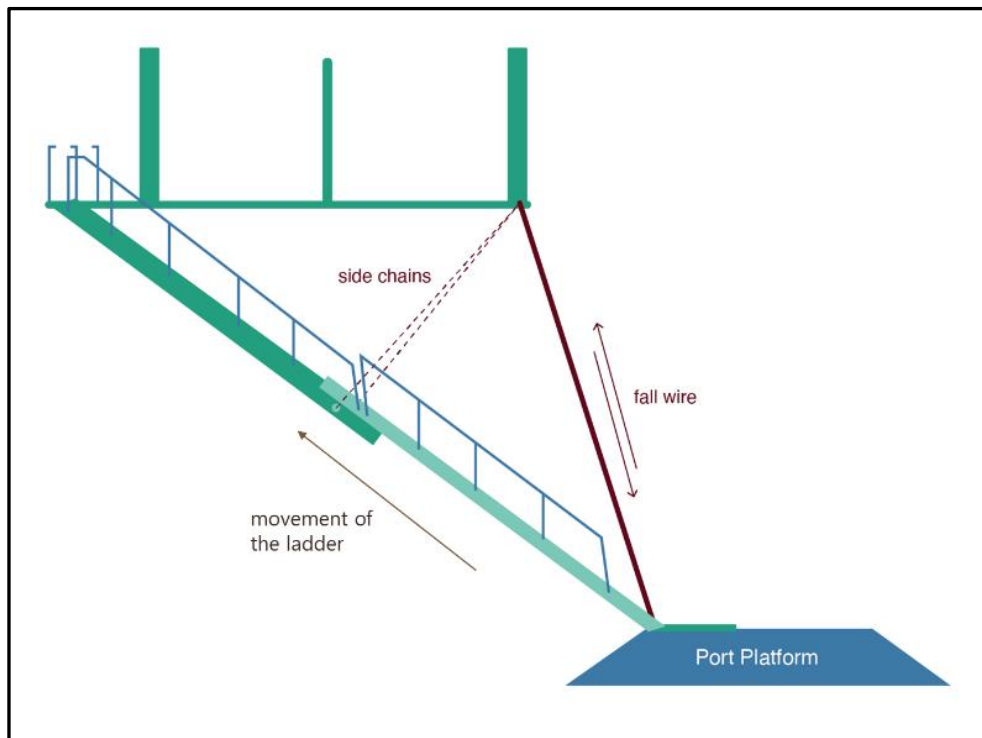
Figure 12: Retrieval of the ladder

- 2.51 The retrieval of the ladder was controlled by a winch used to heave in the fall wire. This resulted in the lower ladder sliding up an interlocking guide in the upper ladder until it reached the end point (see Figure 12).
