Report 10-001: Aerospatale-Alenia ATR 72-212A, ZK-MCP and ZK-MCJ,  
severe turbulence encounters, about 50 nautical miles north of Christchurch, 30 December 2009

# Final Report

Aviation inquiry 10-001  
Aerospatale-Alenia ATR 72-212A, ZK-MCP and ZK-MCJ,  
severe turbulence encounters,  
about 50 nautical miles north of Christchurch,  
30 December 2009

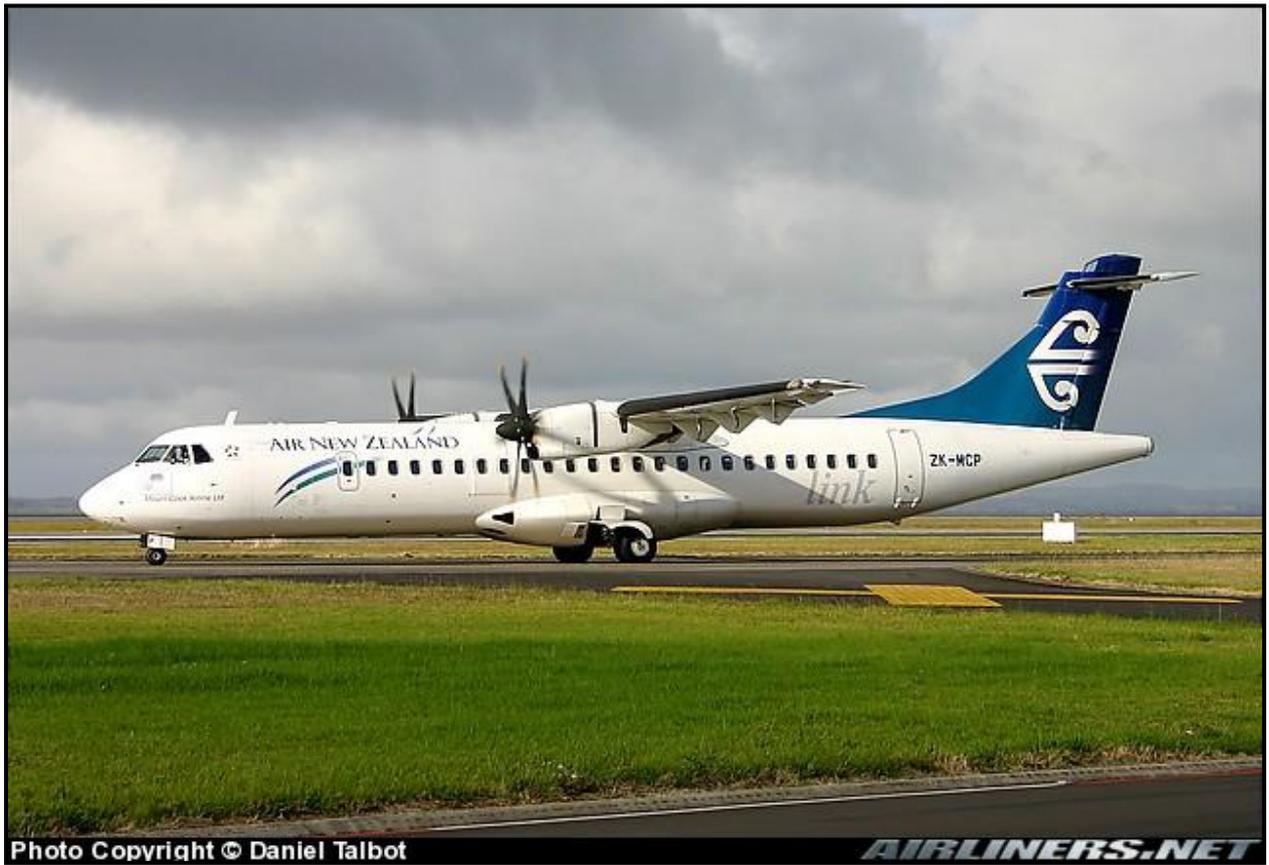
Figure 1 Aerospatale-Alenia ATR 72-212A, ZK-MCP  
(photograph used with permission)
