Inquiry 11-007: Descent below instrument approach minima,
Christchurch International Airport, 29 October 2011

Final Report

Aviation inquiry 11-007
Descent below instrument approach minima
Christchurch International Airport
29 October 2011

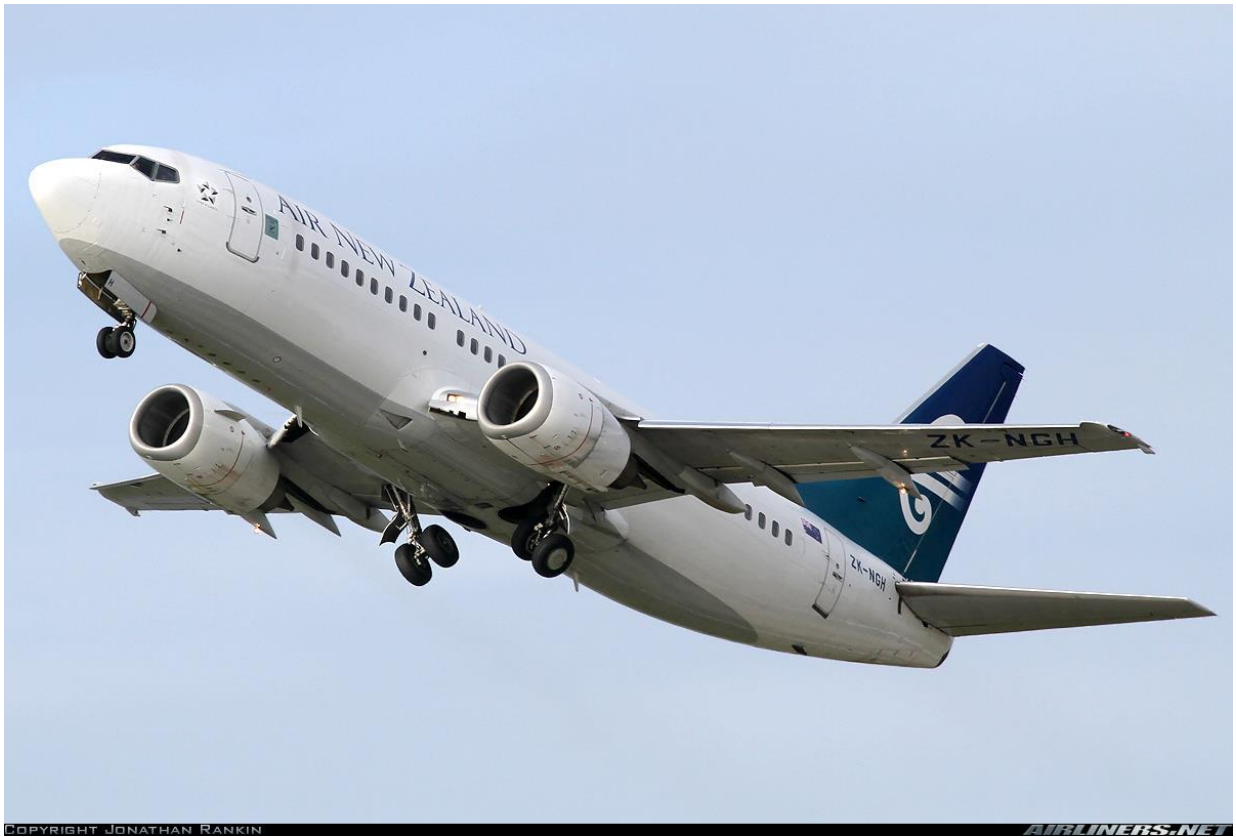
Boeing 737 - ZK-NGH
(Photograph courtesy of Jonathan Rankin)
