Report 96-105

Collision between Shunt L8 and a Hi-Rail Vehicle

St George's Street (near Avondale)

10 May 1996

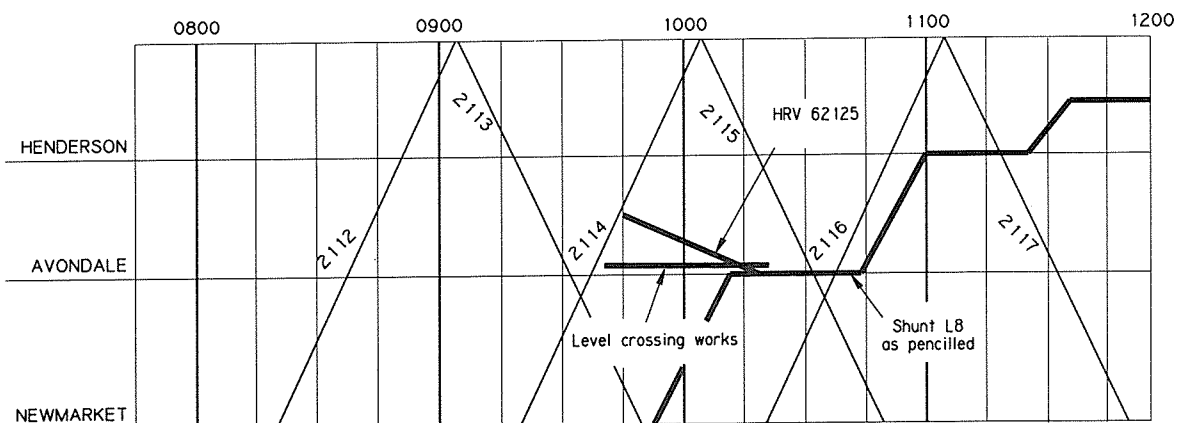
Figure 2
Train Control Diagram as originally plotted

- 1.6 The TCO stated that at this stage he pencilled Shunt L8 on his Train Control Diagram running to Avondale (16.98 km) and entering the loop to clear suburban services 2115 and 2116 before proceeding to Henderson i.e. a path that did not conflict with the level crossing work or the HRV movement (refer Figure 2).
