Report 99-005

ATR 72-212 ZK-MCC and Boeing 737-219 ZK-NAT

airspace incident

Queenstown control zone

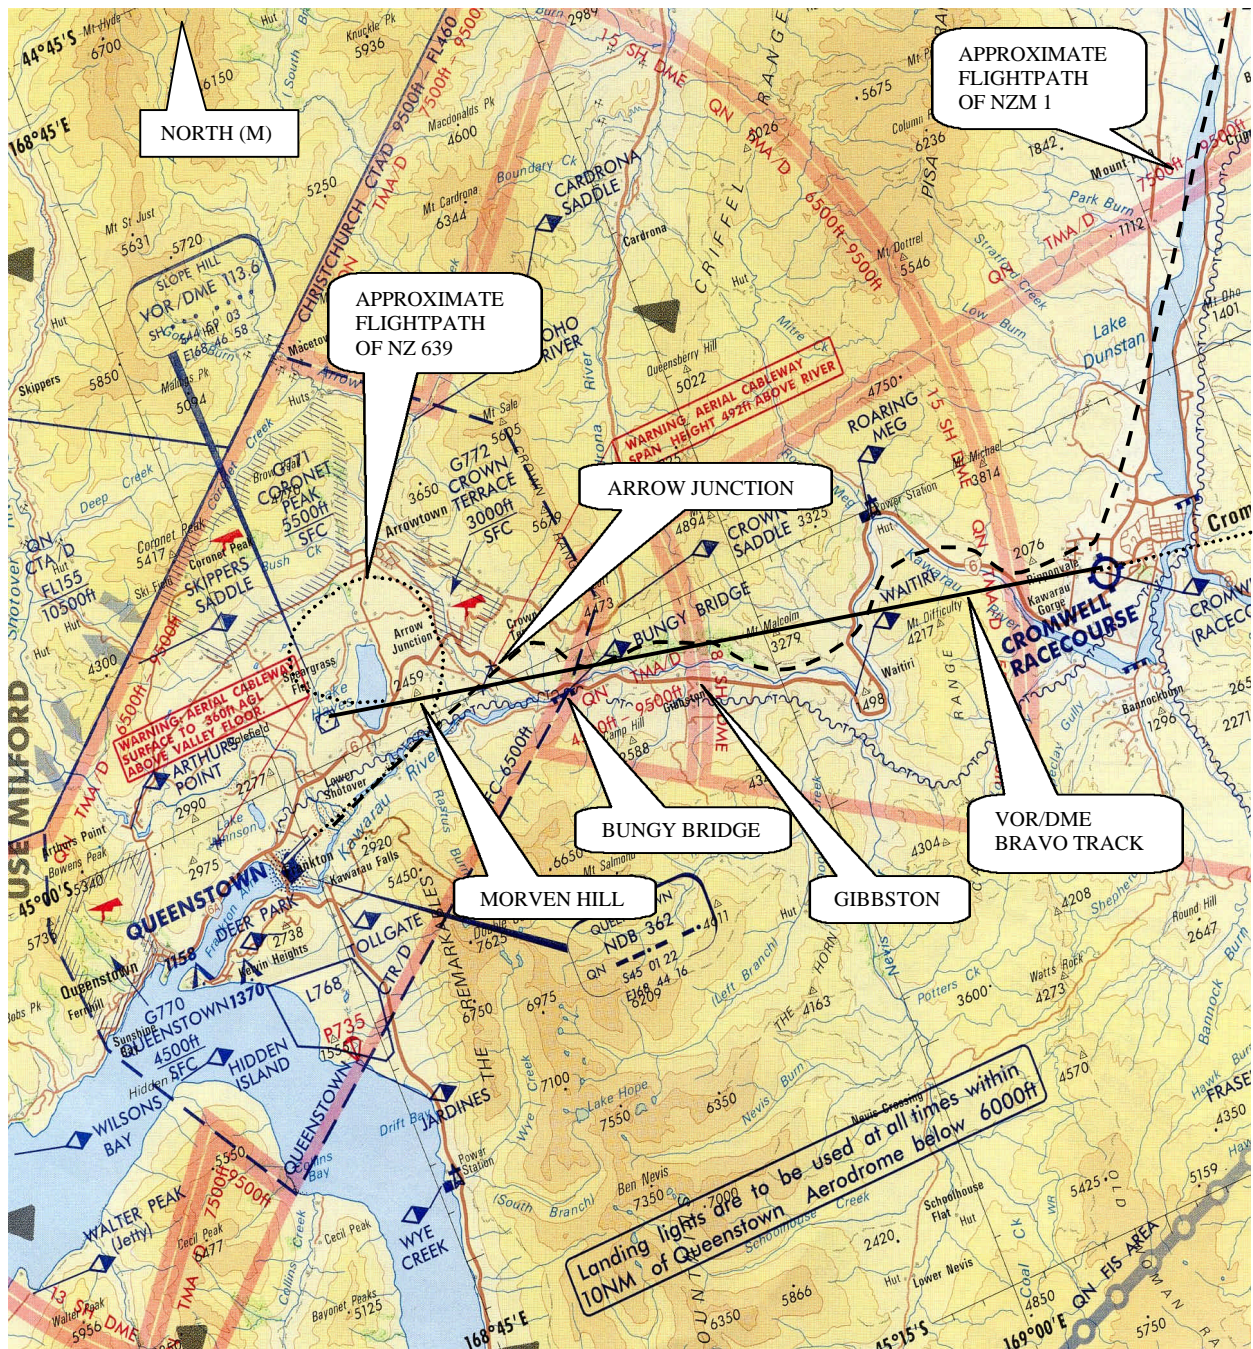
Figure 1
Queenstown Visual Terminal Chart
effective 15 July 1999 (not to scale)

- 1.1.10 At about Tarras, an improvement in the weather had permitted the captain of NZM 37 to cancel the IFR portion of the flight plan with Tower and continue under visual flight rules (VFR) to Queenstown. On cancelling the IFR flight Tower cleared NZM 37 to "track via Cromwell, Bungy Bridge for straight-in runway 23" (see Figure 1). The first officer read back this clearance. As NZM 37 passed through Kawarau Gorge the first officer reported the weather as being "a bit mucky through from Roaring Meg through to Bungy Bridge". NZM 37 then reported at "Bungy Bridge now and joining straight-in for 23, if that's OK". Tower agreed and cleared the aircraft to land.
